# SOIL LIQUEFACTION: MECHANISM, DAMAGE AND COUNTERMEASURES

2014 “Regional Earthquake Disaster Prevention Course” Advanced Edition  
Research Center for Collaborative Area Risk Management (CARM),  
Toyohashi University of Technology  
October 9, Venue: Kamomeria (Port Information Center), Toyohashi City

Kinya MIURA

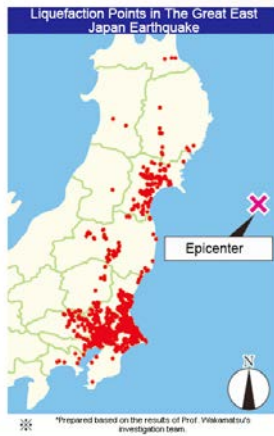
### Liquefaction Points Recorded in The Great East Japan Earthquake

This map shows the distribution of liquefaction points recorded in The Great East Japan Earthquake. It shows the strong influence of ground conditions to the occurrence of liquefaction. What are the conditions for liquefaction to occur? This is one of the lecture's main points.

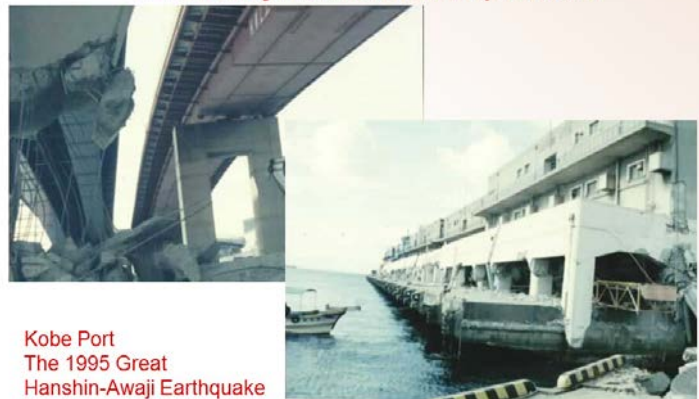
These are examples of quake damage not directly related to liquefaction. During the Great Hanshin-Awaji Earthquake, the impact caused damage to reinforced concrete constructions such as bridges and buildings.

### Seismic Damage to Structures Not Directly Attributable to Liquefaction

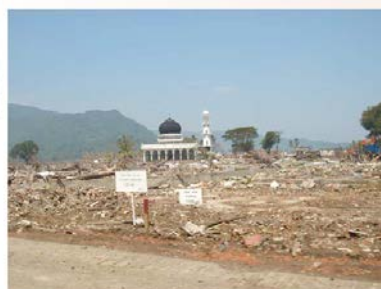
Sumatra Island:  
2004 Sumatra Earthquake

This is an example of quake damage not directly related to liquefaction. During the 2003 Tokachi Offshore Earthquake, fire broke out at an oil-related facility in response to a long oscillation period. During the 2004 Sumatra Earthquake, livelihood was destroyed and many human lives were lost due to tsunami.

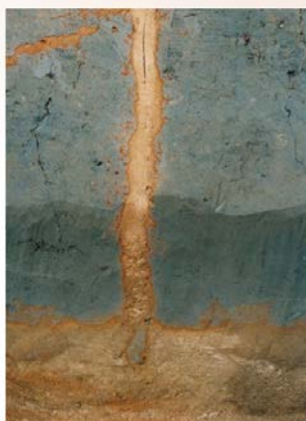
Uchisatohacho Site, Yawata City  
Disaster Prevention Research Institute  
(Kyoto University)

This is a trace of soil liquefaction discovered during excavations at a site dating back to the Middle Yayoi period. Liquefaction is a natural phenomenon that has been occurring since ancient times if conditions were met.

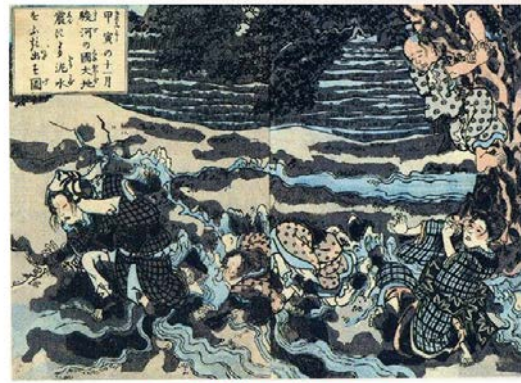
“Ansei Kenbunroku - Part II”:  
The 1854 Ansei Tokai Earthquake (1854), Suruga Province

This part refers to the 1854 Ansei Tokai Earthquake recorded in the ancient chronicle “Ansei Kenbunroku - Part II”. It shows people running about trying to escape from the soil liquefaction occurred in the area that is today part of Shizuoka Prefecture.

#### Liquefaction phenomena recorded in ancient documents

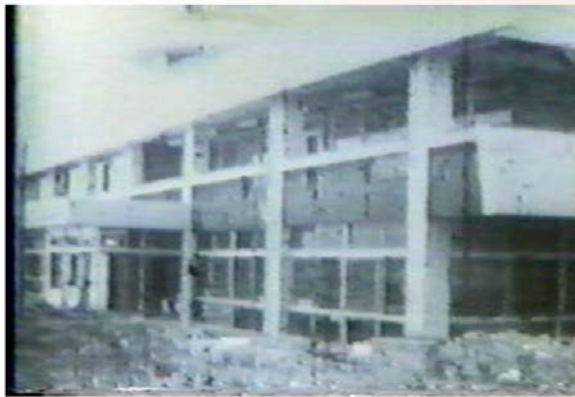
1964 Niigata Earthquake: Sinking terminal building

#### NHK program: the first recording ever to show structural damage caused by liquefaction phenomenon

This is a video taken by Mr. Yuminamochi, a cameraman who happened to be in the terminal building of the Niigata Airport when the earthquake started (later known as the 1964 Niigata Earthquake). This is one of the most valuable materials for the study of geotechnical earthquake engineering since it made widely known how severe and important was the soil liquefaction phenomenon affecting modern facilities.

soil lost its bearing capacity and caused the airport's building to sink more than 1m.

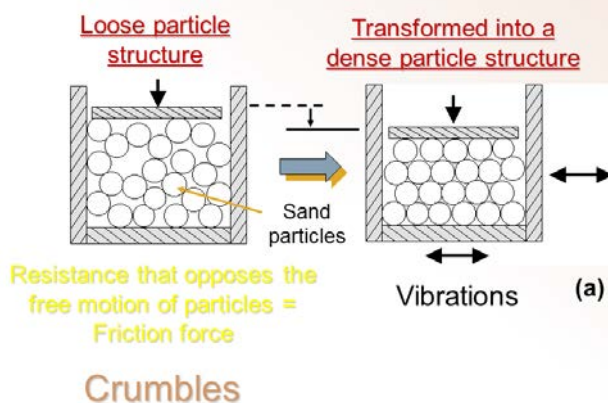
### Vibration of loose particle structures

When subjected to vibrations, loose soil particles easily change their array structure causing the soil volume to shrink. It is during this process that liquefaction occurs.

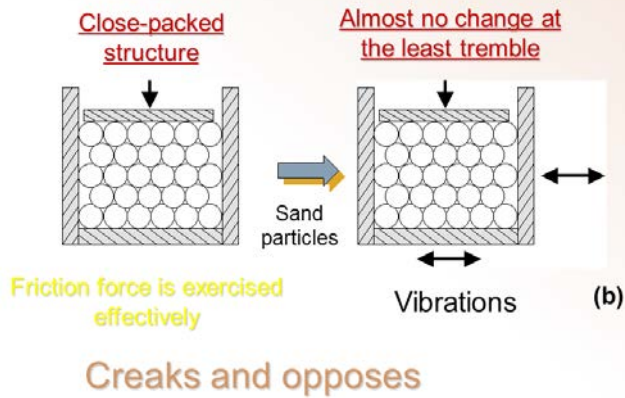
### Vibration of dense particle structures

On the other hand, dense soil particles do not change their array structure regardless of the strong vibrations they're subjected to. Therefore, it can be said that liquefaction does not occur in dense soils

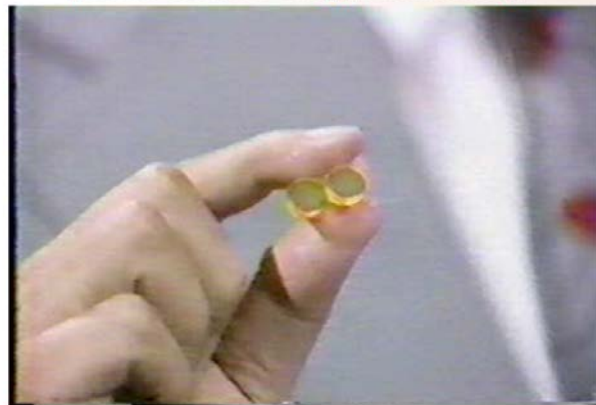
### NHK program: microscopic study of particle structure using photoelasticity

When a soil is saturated with groundwater, no matter the vibrations it is subjected to, its volume will not modify immediately. In this experiment, applying vibration while soil volume remains constant is causing peak shearing deformation.

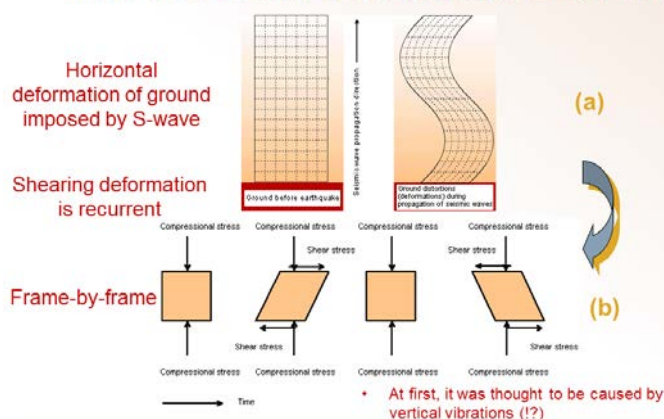
### Seismic wave transmission. Liquefaction phenomenon onsets due to shearing deformations imposed by S-wave

We have learned from the photoelasticity experiment that it is the horizontal peak shearing deformation, as illustrated here, that causes soil liquefaction. We thus understand now that a transverse wave (S-wave, principal shock) is a dangerous vibration mode also for structures, as dangerous as the horizontal peak vibration in soil liquefaction.

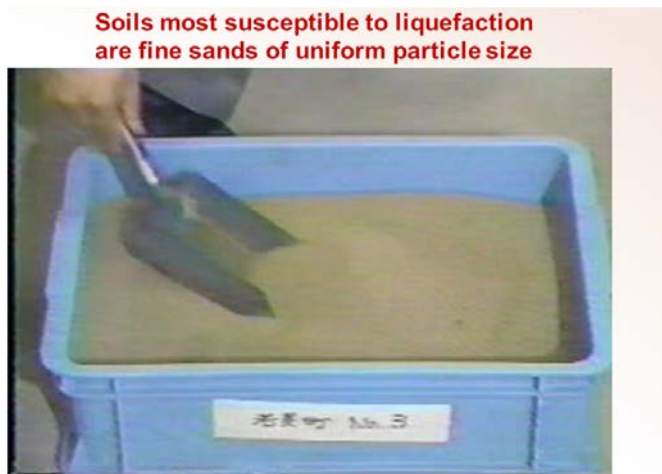
This video shows the characteristics of both liquefied and non-liquefied soils. We learn that soils with high risk of liquefaction are fine sands of uniform particle size.

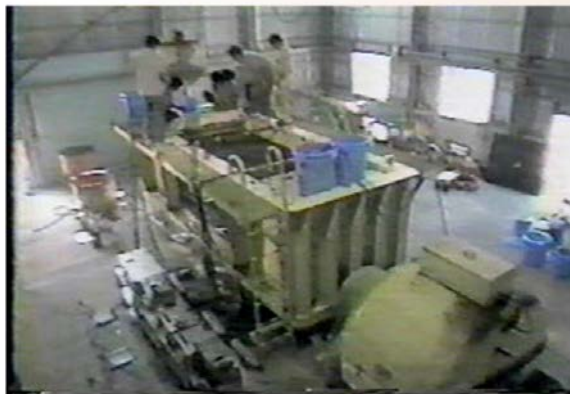
**NHK program: the process of liquefaction and types of disaster verified by shaking table test**

The video is a recording of a simulation test of soil liquefaction phenomenon, which was conducted at the Research Institute of the Ministry of Transport (currently the Ministry of Land, Infrastructure, Transport and Tourism). Soil meeting all the requirements to undergo liquefaction is constructed on the shaking table, and various structures are disposed on top. The shaking table enables accurate reproduction of observed seismic motions.

Poles and heavy structures are drawn inside the ground and thus sink. Meanwhile, light structures float due to buoyancy effects. In either cases, damages are critical.

The test reveals that pore water pressure is generated in deep layers, which causes groundwater and soil to circulate towards the ground surface.

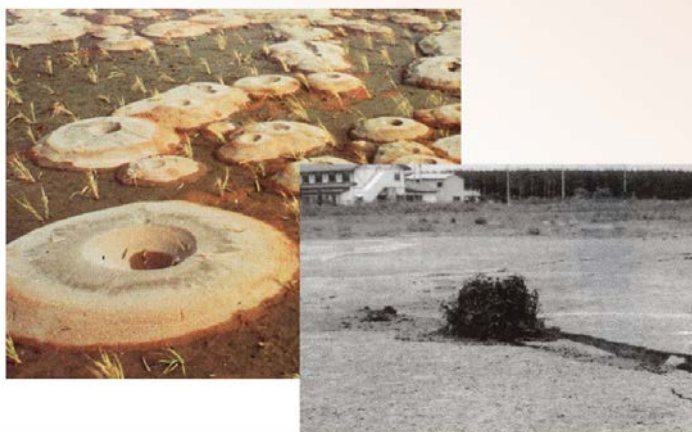
**Traces of Liquefaction (Sand boils & holes)**

The images show a sand boiling and sand boil holes, which indicate traces (evidences) of liquefaction. These were observed in the Middle Japan Sea Earthquake.

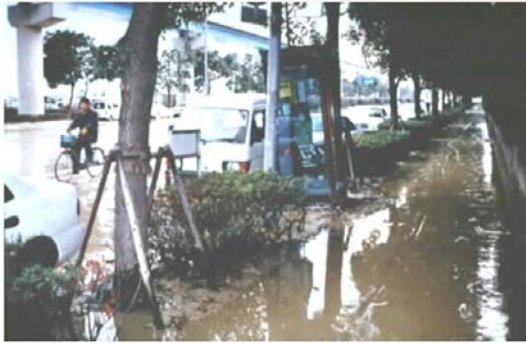
The 1995 Great Hanshin-Awaji Earthquake: Central part of Port Island, Kobe City

### Water fountain and ground sinkage in reclaimed lands

It looks completely like a flood area

During the Great Hanshin-Awaji Earthquake, Port Island underwent massive liquefaction, and great amount of groundwater gushed up through the ground surface. Immediately after that, the surroundings looked like they had been hit by floods.

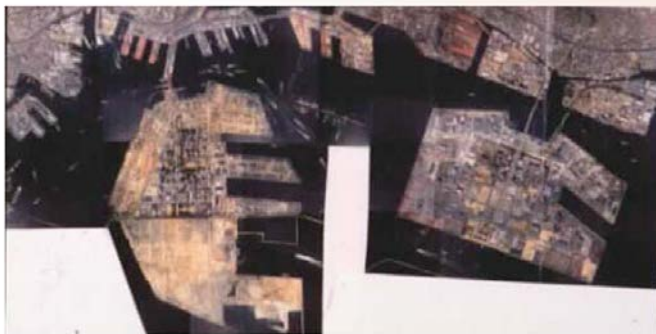
### Liquefaction phenomenon captured in satellite image

This is a satellite image taken just after the Great Hanshin-Awaji Earthquake. We can infer from the sand boils shown in other that liquefaction onset extensively in Port Island and Rokko Island.

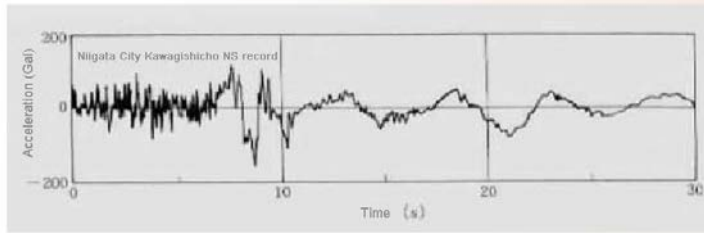
### Damage due to changes in vibration characteristics

- Ground acceleration recorded in Kawagishicho, Niigata City (1964 Niigata Earthquake)
- In the wake of the earthquake, soil liquefaction onset near the 8-second vibration frequency.
- The natural period afterwards was around 5 seconds.

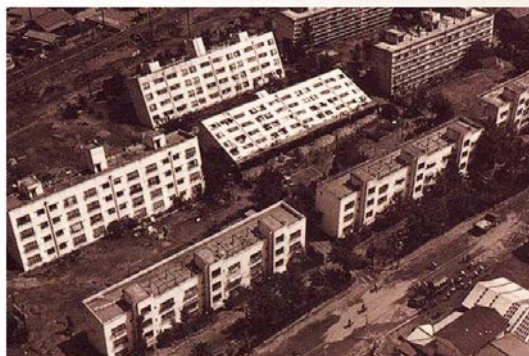
### Subsidence and fall of structures: Kawagishicho apartment complex, Niigata City (1964 Niigata Earthquake)

- Several buildings tipped over
- However, there was no remarkable structural damage

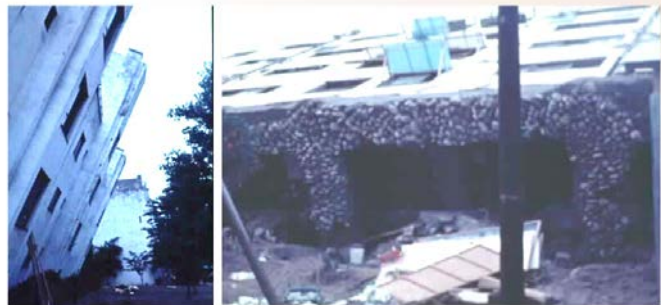
**Subsidence and fall of structures: Kawagishicho apartment complex, Niigata City (1964 Niigata Earthquake)**

- Spread foundation (strip foundation) with no piers to support them
- The superstructure was almost intact; there was also little human damage

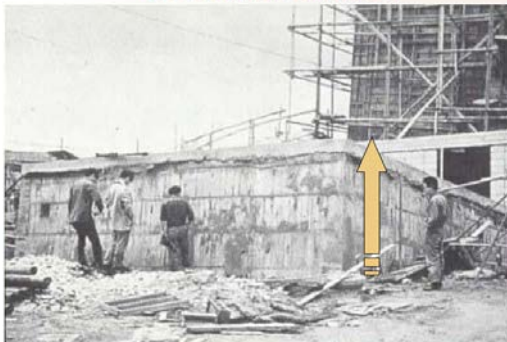
**Buoyant buried utilities: Water storage tank, Niigata Port (1964 Niigata Earthquake)**

- The empty water storage tank floated upward due to the effects of a buoyant force two times higher than that of water

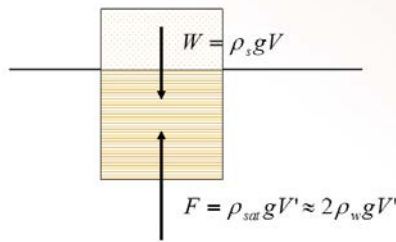
### Buoyant buried utilities: Water storage tank, Niigata Port (weight-buoyant force balance)

- When soils liquefy, they are exposed to a buoyant force.
- This force is twice higher than when under the water.
- Concrete containers and pipes also float, if empty.

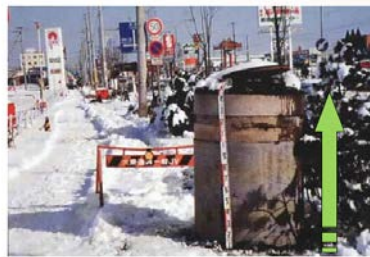
### Buoyant buried utilities: Sewage pipelines, Kushiro Town (1993 Kushiro Offshore Earthquake)

- Manholes floated up 1.4m
- No liquefaction observed in the surrounding ground

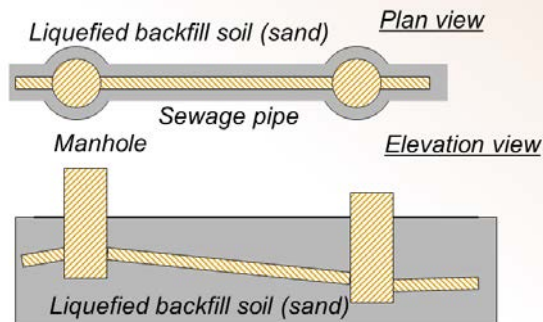
### Buoyant buried utilities: Sewage pipelines, Kushiro Town (1993 Kushiro Offshore Earthquake)

- After excavations and laying of the pipeline, the backfill soil liquefied.
- The pipeline didn't break, it floated up entirely

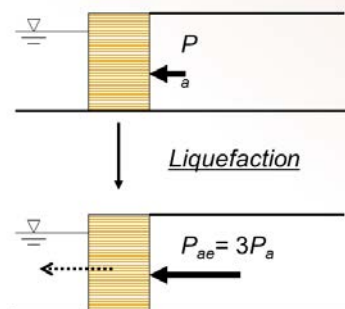
### Uplift of anti-earth pressure constructions (retaining walls, etc.): Earth pressure increase

- Earth pressure in waterfronts increases three times due to liquefaction.
- Anti-earth pressure constructions such as retaining walls are lifted up.

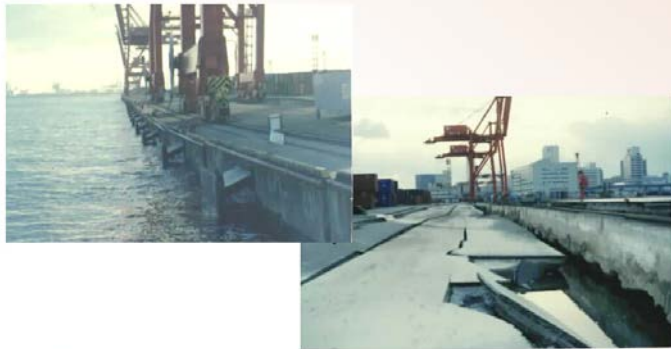
### Uplift of anti-earth pressure constructions: Gravity quay walls, Kobe Port (1995 Southern Hyogo Prefecture Earthquake)

- Due to earth pressure increase, the front face of the quay walls swelled, and the back ground subsided greatly

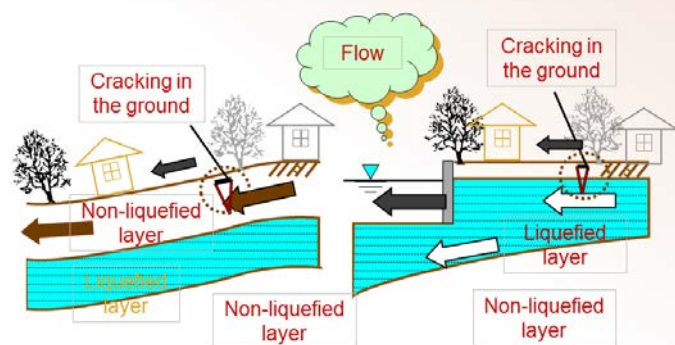
### Soil liquefaction flow. Flow mechanism

- Liquefaction causes soils to flow down slopes to lower ground
- Flow failures also form when constructions like retaining walls break.

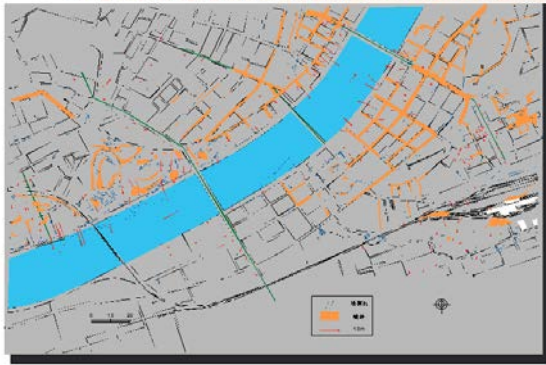
### Lateral ground flow: Shinano River area, Niigata City (1964 Niigata Earthquake)

- The riverbank moved horizontally a max. distance of 5m

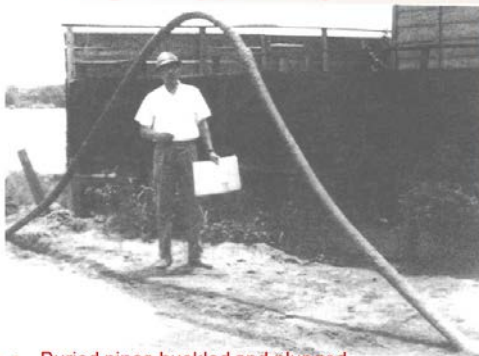
### Lateral ground flow: Buried pipes in Niigata City (1964 Niigata Earthquake)

- Buried pipes buckled and plunged
- They were compressed at low ground, and pulled up to high ground

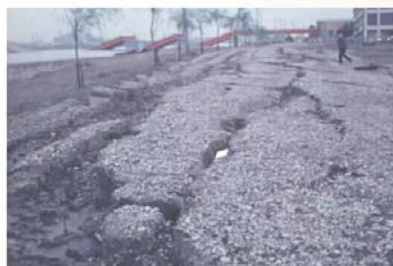
### Lateral ground flow: Shinano River bank, Niigata City (1964 Niigata Earthquake)

- Multiple cracks appeared parallel to the river
- The riverbank submerged into the water

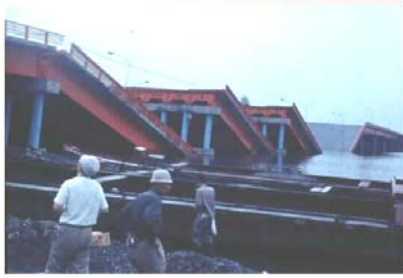
### Lateral ground flow: Showa Bridge, Niigata City (1964 Niigata Earthquake)

- The piers and abutments were extruded to the center of the river by the liquefaction flow
- Multiple girders fell off: about 1 month after opening to traffic

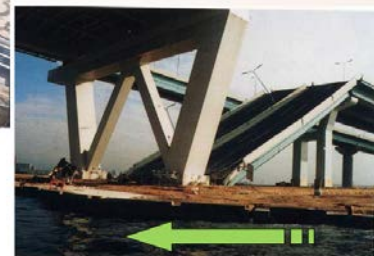
Rokko Bridge, Kobe City  
(1995 Southern Hyogo Prefecture Earthquake)

During the Great Hanshin-Awaji Earthquake, Rokko Bridge was damaged and girders fell. This was caused by the lateral displacement following liquefaction of soil near the bridge piers.

### Girders fell off due to the lateral ground flow

- Pier were extruded toward the river by liquefaction in sloping ground

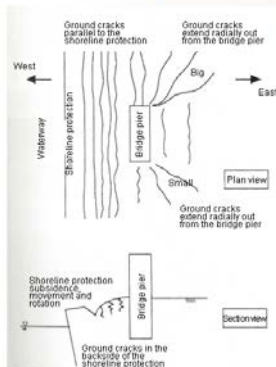
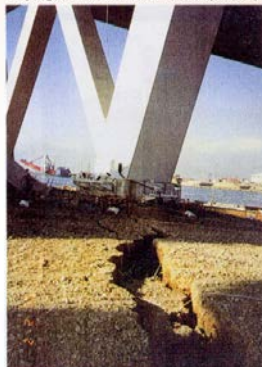
### Traces of lateral ground flow Rokko Bridge, Kobe City (1995 Southern Hyogo Prefecture Earthquake)

- Cracking in the ground surface shows how ground pushed out the bridge abutment

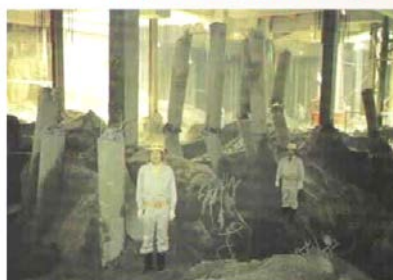
### Lateral ground flow: Buildings along Shinano River, Niigata City (1964 Niigata Earthquake)

- At the time of reconstructing the buildings where earthquake-induced lateral movement was recognized, surveys were conducted to determine the damage situation of their pile foundation
- Almost all piles were broken due to lateral load

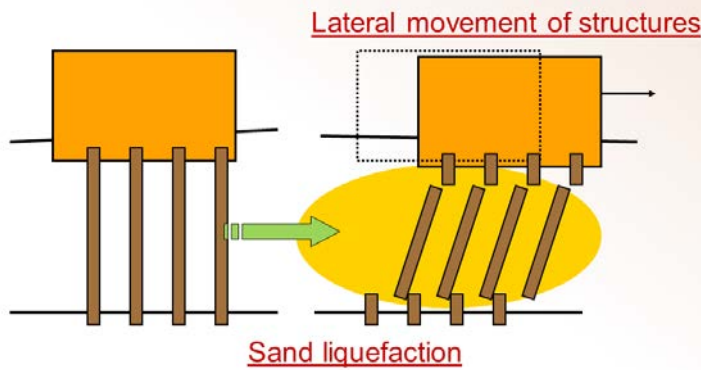
### Lateral ground flow. Pile foundation damage mechanism

- The bending load acts on the piles and causes double cracks in each pile

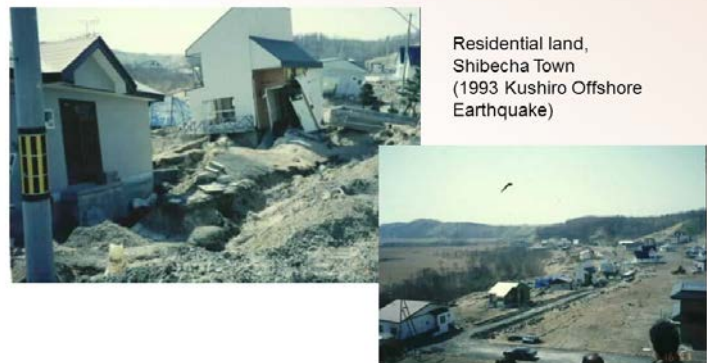
### Many houses were damaged by embankment flow

- Dozen houses built on embankment were all partially destroyed

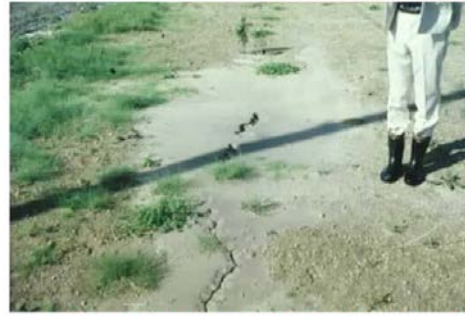
Residential area,  
Shibecha Town  
1994 East-off Hokkaido  
Earthquake

This region was hit again by earthquake eastward offshore of Hokkaido the following year, but this time the surface wasn't covered by snow, making the traces of sand boils, which are thought to be signs of liquefaction, visible on the surface of the embankment.

### Sand boil observed in embankment affected by flow failure

- Same damage was induced during earthquake that hit eastward offshore of Hokkaido the next year
- Sand boils were recognized as evidence of liquefaction

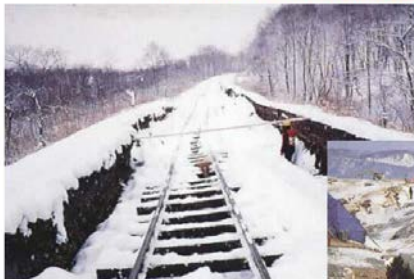
Kushiro City  
(1993 Kushiro Offshore  
Earthquake)

### Various types of embankment couldn't maintain their function as many of them collapsed

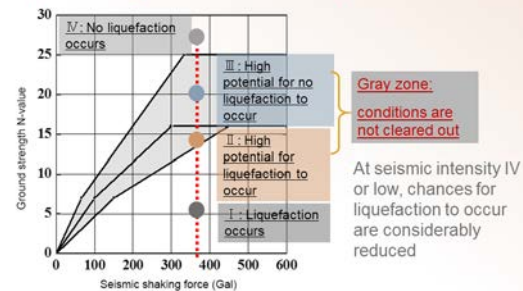
### Comparison of ground vibration and liquefaction resistance

- The risk is higher when quake intensity exceeds the ground strength
- Cannot improve accuracy of analysis due to the large gray zone

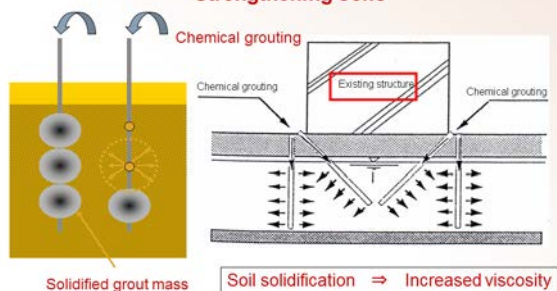
#### Strengthening soils

- Enables construction work also at the existing buildings
- However, not economic

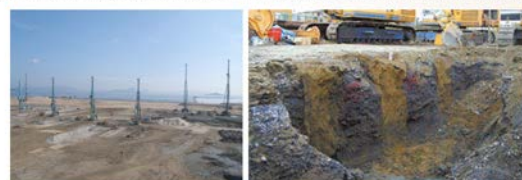
- Sand compaction pile method

This method is used to prevent soil liquefaction by solidifying the ground in compacting it. It prepares the ground through the insertion of sand compaction piles into the ground, by inserting and extracting a casing pipe repeatedly with a vibro-hammer.

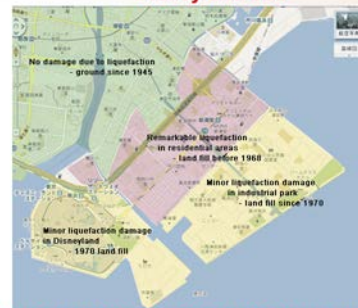
## Status of liquefaction mitigation implementation around Disneyland Sea

- No measures have been adopted in the parking area
- No measures have been either adopted in the residential area
